MARYLAND HISTORICAL TRUST

INVENTORY FORM FOR STATE HISTORIC SITES SURVEY

802-12, 840-44, 841, 843, 845, 846, 848, 850, 852, 858, 860, 863, 877^{West}, Fairmount Ave.

Baltimore

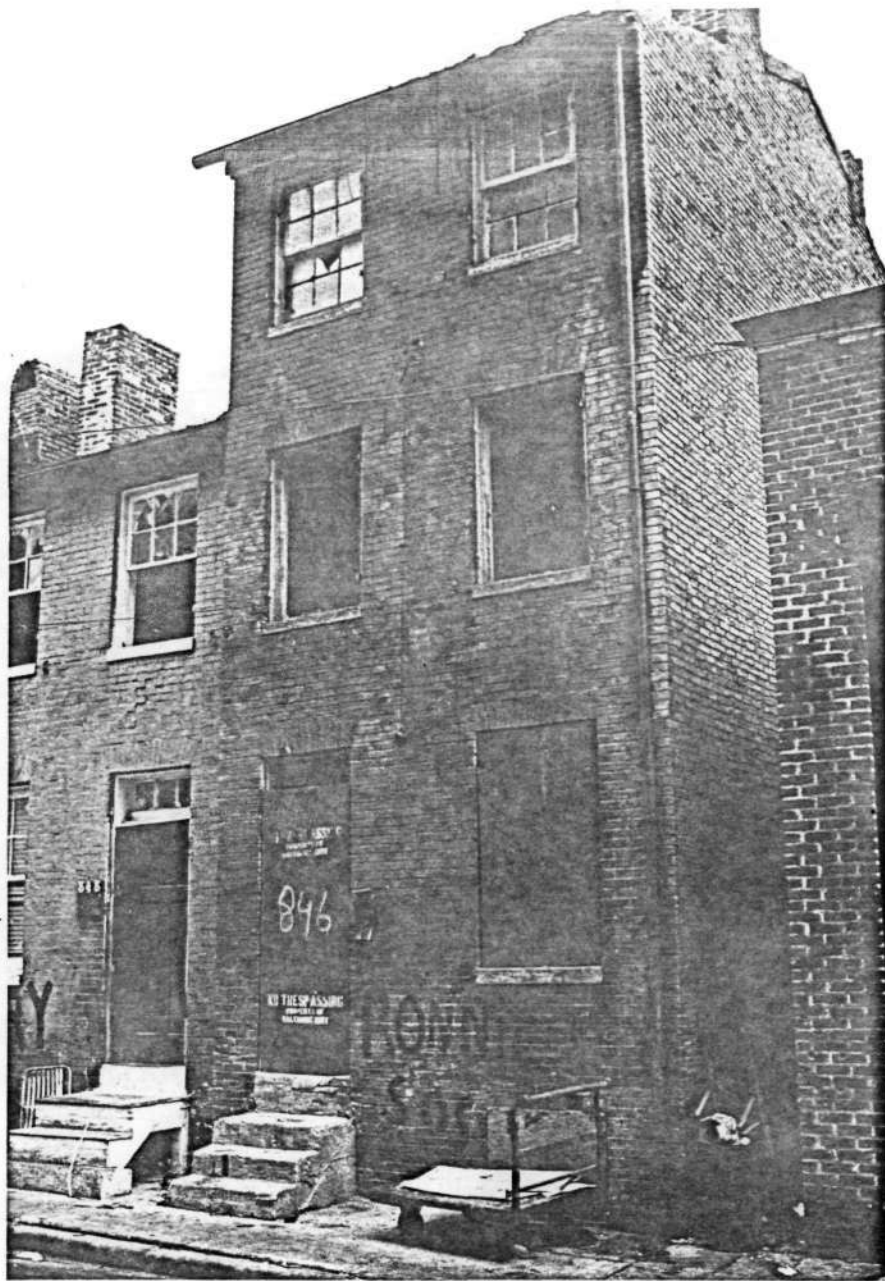
846 W. Fairmount Avenue

846 Fairmount Avenue is a three storey, two bay building with a gabled roof. The building is laid in American common bond with headers every ninth row. The windows have six-over-six lights and flat arched lintels. There is a small cellar window in the left bay. With the exception of the third storey windows, the remaining windows are boarded up. The single-leaf door is located in the left bay. It has a flat-topped transom with a flat arched lintel. The building has a simple brick cornice. 848 and 850 are similar in design as 846. They are two stories tall instead of three and their windows have six-over-one lights. 850 has a star detail in the center of the front facade. 848 and 850 are presently vacant.
